CONNECTICUT RIVER BASIN  
NEW BRITAIN - SOUTHTON, CONNECTICUT

# SHUTTLE MEADOW RESERVOIR DAM CT 00162

## PHASE I INSPECTION REPORT NATIONAL DAM INSPECTION PROGRAM

MARCH 1979

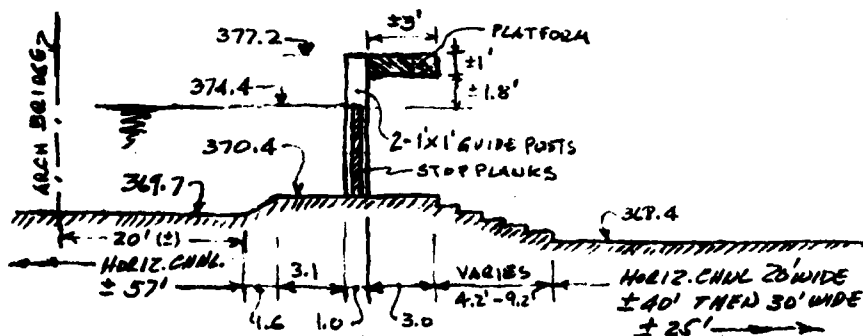
X-SECTION @ SPWY. SILL

WITH A CENTRAL ONE-PIECE SILL 10.0' HIGH FROM THE APPROACH SECTION OF THE CHANNEL. ON THE RIGHT, STOP PLANKS (NOT FISH BOARDS) ARE IN PLACE, RAISING THE ACTUAL CREST ELEVATION OF THE OUTFLOW GATEWAY TO (1) ELEV. 377.2' MSL (12' 4" ABOVE THE PERMANENT SILL ELEV. 370.4' MSL) - (SEE SKETCH) BESIDE 2-STEEL GUIDE POSTS (2" SQ. IN.) FOR THE SUPPORT OF THE PLANKS WHICH EXTEND TO (2) ELEV. 377.2' MSL THERE IS A PLATFORM, 3' WIDE X 1' THICK, WITH TOP ELEV. 377.2' MSL (TO SERVE THE STOP PLANKS) AND AN ARCH BRIDGE (8.8' CLEARANCE AT THE CROWN X 6.4' AT THE SIDES, 20' SPAN), OBSTRUCTING THE CHANNEL.

(SPILLWAY CHANNEL 20' WIDE, TOP OF WALLS EL. 380.6' MSL)

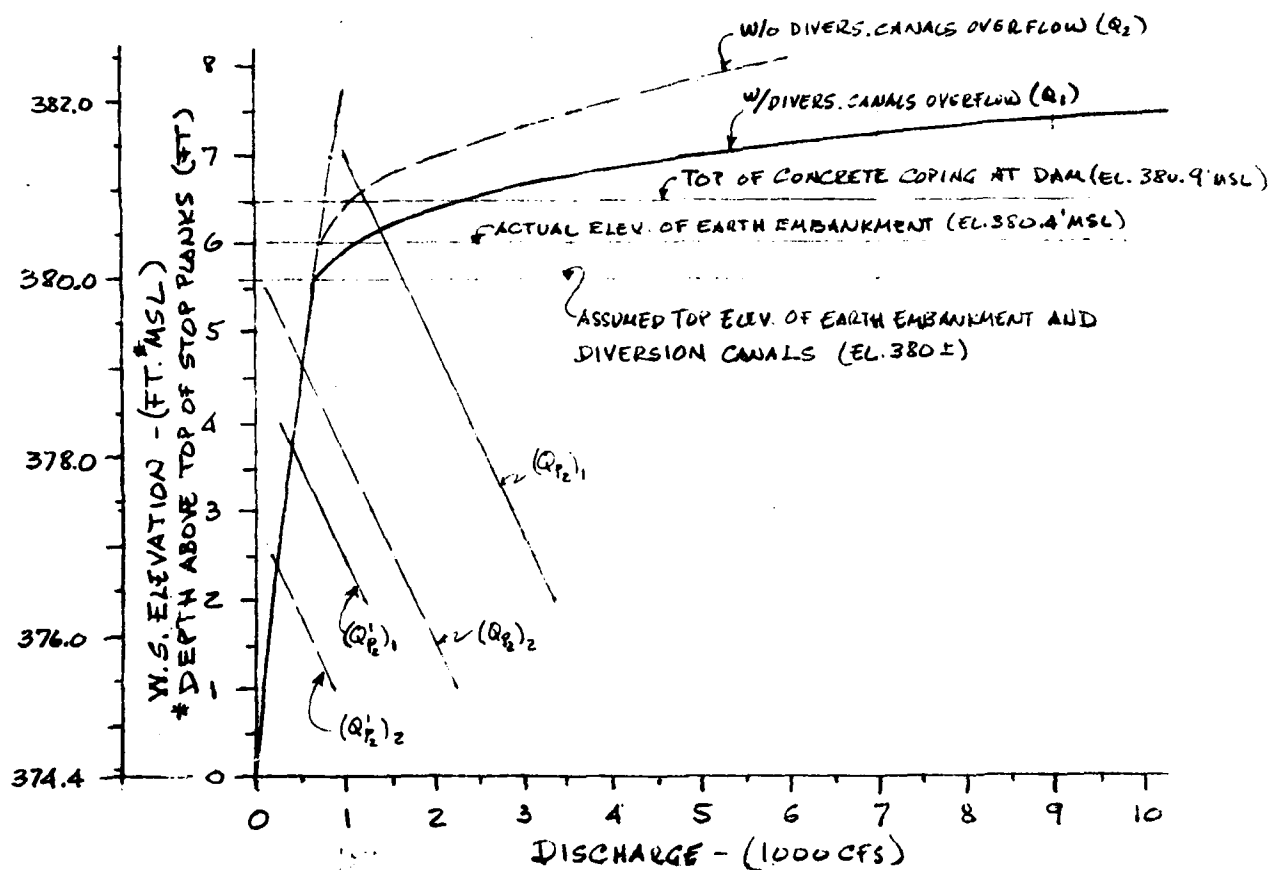
### 3-Cont'd) OUTFLOW RATING CURVE

DEPTH IS REFERRED TO TOP OF THE STOP PLANKS WHICH IS CONSIDERED THE PRESENT SPILLWAY CREST ELEV. FOR THE DAM. IF THE STOP PLANKS WERE REMOVED THE CREST ELEV. WOULD BE ELEV. 370.4' MSL (4' LOWER) AS THIS IS THE ELEVATION OF THE SPILLWAY CHANNEL SILL. HYDRAULIC CHARACTERISTICS IN THIS CASE WILL BE, FOR RELATIVELY LARGE DEPTHS, MORE THOSE OF A CHANNEL W/O OBSTRUCTIONS/CONSTRICTIONS THAN THOSE GIVEN BY A WEIR FLOW FORMULA. ITS CAPACITY IS EXPECTED HOWEVER TO REMAIN ONLY A SMALL FRACTION OF THE PEAK INFLOW. D-16
